Recreation of cultural historical values in buildings from before 1945: Inventory with focus on building physics performance

JOHANSSON Pär^{1,a*} and WAHLGREN Paula^{1,b}

¹Department of Civil and Environmental Engineering, Chalmers University of Technology,
412 96 Gothenburg, Sweden

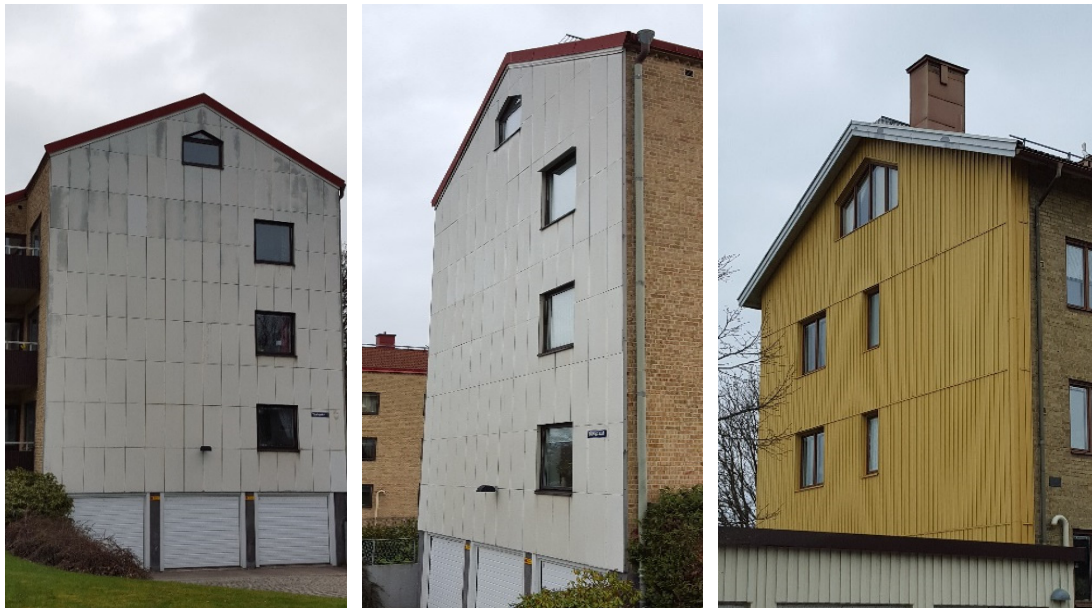
The façades facing south are overrepresented when it comes to additional insulation. This is in particular common when there are few windows in the south façade. This is probably due to the fact that Gothenburg has a large amount of driving rain with predominant direction from south/south-west. Driving rain often cause water leakage into the façades [13]. Furthermore, solar radiation can cause deterioration of the façade material, both due to UV-radiation and thermally induced stresses and the southern facades are very exposed in this respect. An example of two renovated façades facing south is shown in Figure 7.

Figure 7. Often the south façade is renovated. Examples of two different strategies where cementitious boards (left) and a metal cladding (right) were chosen on the south facade.

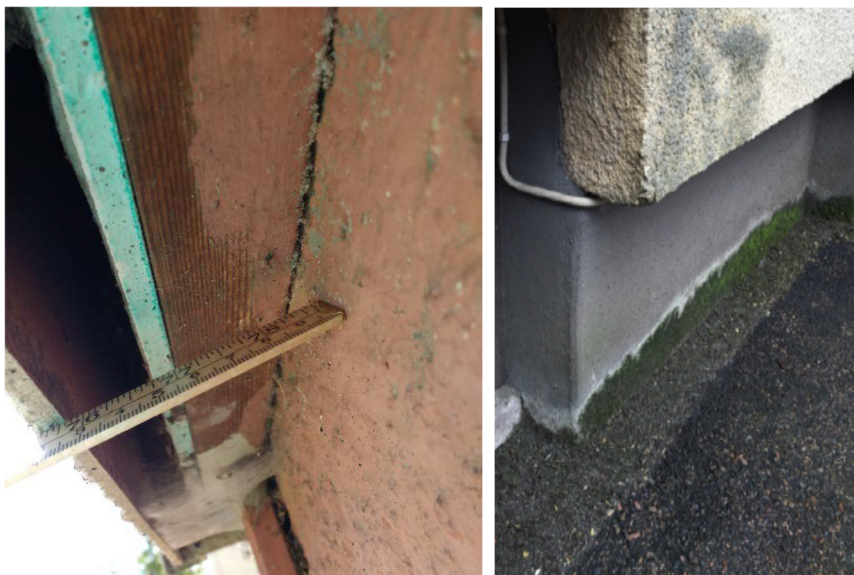
The inventory showed that great care has to be taken when adding insulation to exterior walls. In cases where there is no air gap in the façade and exterior insulation has been added, the façade is more often damaged than façades with an air gap. Furthermore, the additional insulation is more often wet when there is no air gap in the façade.

Façades that have insulation or a new rain barrier all the way to the ground, see Figure 8, are almost always damaged, with the exception of façades of concrete, brick or very thick plaster.

Figure 8. Example of two façades with additional insulation, seen from below.
